POUDRE SCHOOL
DISTRICT
LOPEZ ELEMENTARY
SCHOOL

FACILITY CONDITION ASSESSMENT

FORT COLLINS, CO

OCTOBER 2023

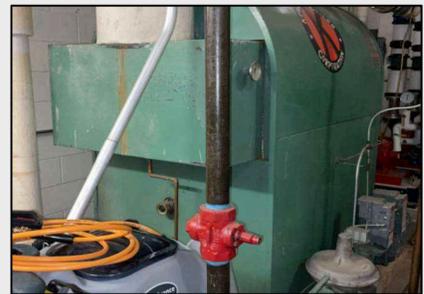
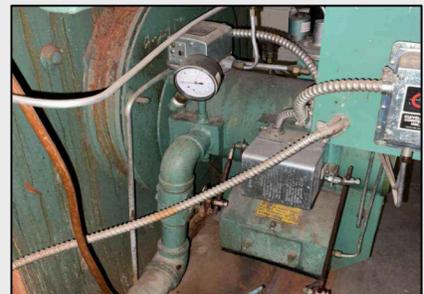
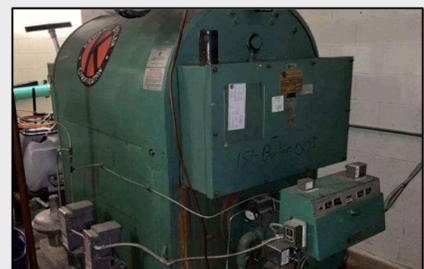
1. Replace the Original Boiler

The original heating water boiler is currently 37 years old, and has surpassed its recommended lifespan. [REDACTED] should be prioritized for replacement within the next 3 years. Replacing this unit will ensure that the building has a reliable and efficient heating source.

- Boiler 1 (FCAID-360084)
- Pump P-5 (FCAID-360094)

Priority Level:	1
Estimated Cost:	\$98,610
Remaining Life:	3 years

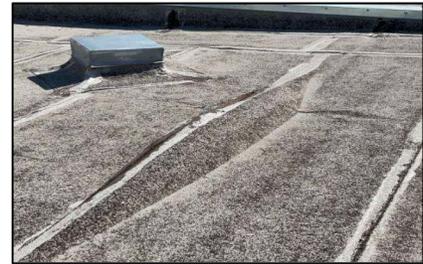
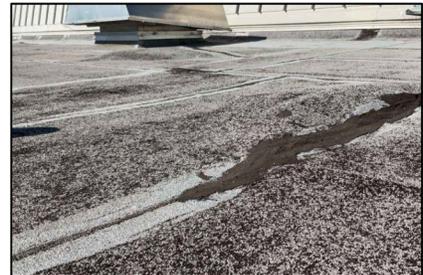
2. Replace the Roofing

The roofing was found to be in poor condition, with areas of severe bubbling and surface separation. These bubbles are at risk for moisture infiltration into the structure if not addressed, therefore the replacing or refurbishing the roofing should be prioritized in the next 4 years. Based on available documentation, portions of the roofing were replaced in 2010, which may be under warranty.

- Roofing, Rolled Asphalt (FCAID-360015)

Priority Level: 2
Estimated Cost: \$364,020
Remaining Life: 4 years

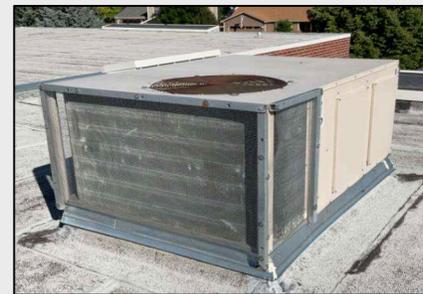
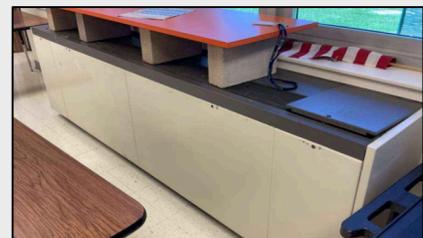
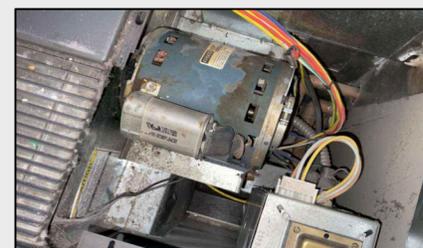
3. Replace or Refurbish Outdated HVAC Equipment

Generally, the assets included in this measure were installed between 1980-2001, and have reached the end of their industry recommended lifespan. Plan for replacement of these assets over the next 2-5 years to ensure the systems is functioning as designed.

- AHU-1 (FCAID-360042)
- AHU-2 (FCAID-360043)
- Gym AHU (FCAID-360047)
- RTU-2 (FCAID-360146)
- SF-1 (FCAID-360147)
- UV-54 (FCAID-360149)
- RTU-1 (FCAID-360145)
- EF-13 (FCAID-360061)
- SF-2 (FCAID-360148)
- Kitchen Hood (FCAID-360096)
- CH-1 (FCAID-360051)
- CH-2 (FCAID-360052)
- CH-2 (FCAID-360053)
- CH-4 (FCAID-360054)
- CH-4 (FCAID-360055)
- FCU-1 (FCAID-360057)
- (11) Exhaust Fans (FCAIDs vary)
- Convector (FCAID-360144)

Priority Level: 2
Estimated Cost: \$577,850
Remaining Life: 2-5 years

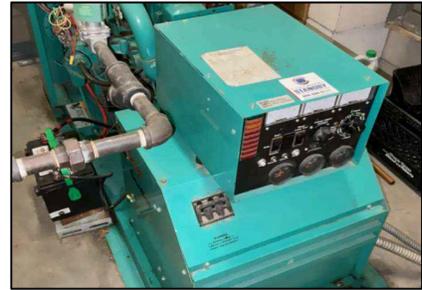
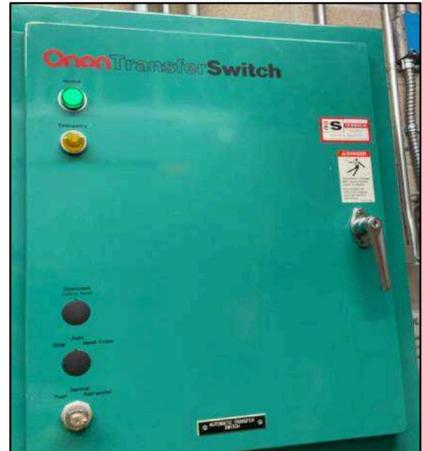
4. Replace the Generator

The building's backup power supply is provided by a 23 kVA generator, installed when the building was constructed circa 1986. [REDACTED]

- Backup Generator (FCAID-360151)
- ATS (FCAID-360150)

Priority Level: 2
Estimated Cost: \$29,050
Remaining Life: 2 years

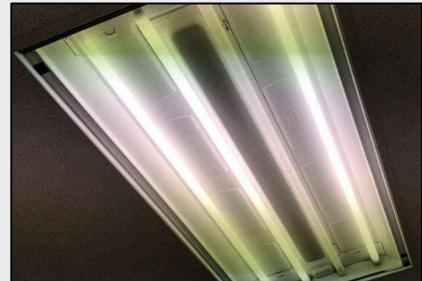
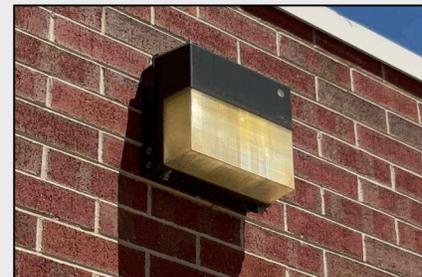
5. Replace Fluorescent and HID Lighting

While a portion of the building's lighting has been converted to LED, including the gymnasium and library, portions of the building still utilize fluorescent technology. Additionally, a number of exterior building-affixed lighting fixtures utilize high intensity discharge (HID) lamps. Replacing these fixtures with LED lighting will reduce energy and maintenance costs of the building.

- Interior Lighting: Fluorescent (FCAID-360156)
- Exterior Lighting, HID (FCAID-360152)

Priority Level: 3
Estimated Cost: \$776,770
Remaining Life: 3-5 years
