POUDRE SCHOOL DISTRICT MCGRAW ELEMENTARY SCHOOL

FACILITY CONDITION ASSESSMENT

FORT COLLINS, CO

OCTOBER 2023

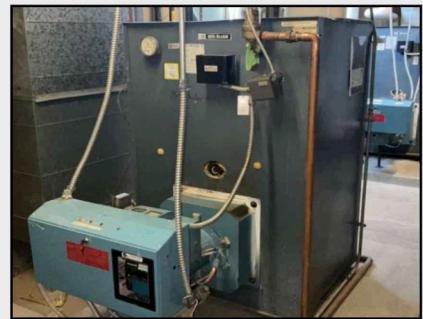
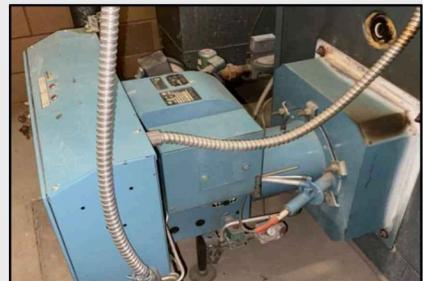
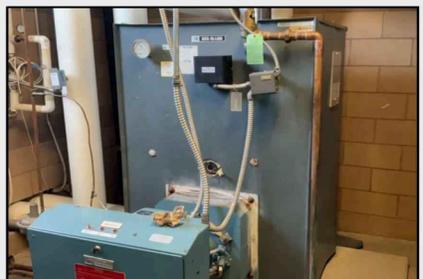
1. Prepare for Boiler Replacements

The building utilizes two natural gas fired hydronic boilers which were installed in 1991. These boilers are expected to reach the end of their lifespan within 3-5 years, and will likely require some level of refurbishment or a full replacement. Plan to address these assets within this period to ensure that the building's heating system is running efficiently, and as reliably as possible.

- Boiler 1 (FCAID-370092)
- Boiler 2 (FCAID-370093)

Priority Level: 2
Estimated Cost: \$157,260
Remaining Life: 5 years

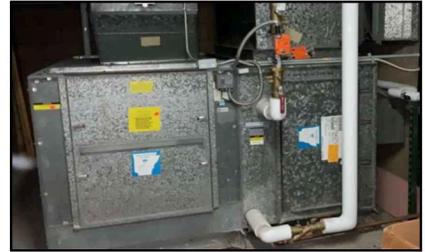
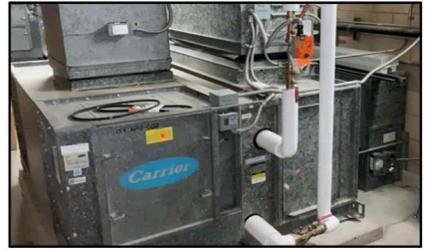
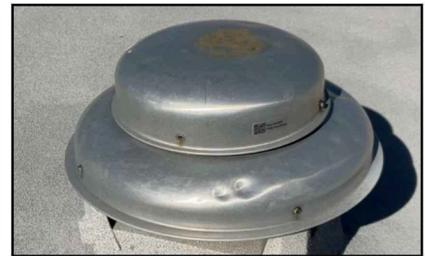
2. Update Outdated Ventilation Assets

Many of these assets are original to the building's 1991 construction and are due for replacement.

- AHU-1 (FCAID-370040)
- AHU-2 (FCAID-370041)
- CUH-3 (FCAID-370047)
- CUH-4 (FCAID-370048)
- CUH-5 (FCAID-370049)
- CUH-6 (FCAID-370050)
- CUH-7 (FCAID-370051)
- (23) Exhaust Fans (FCAIDs vary)

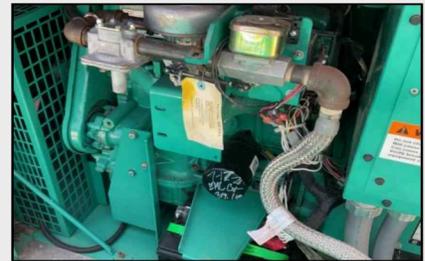
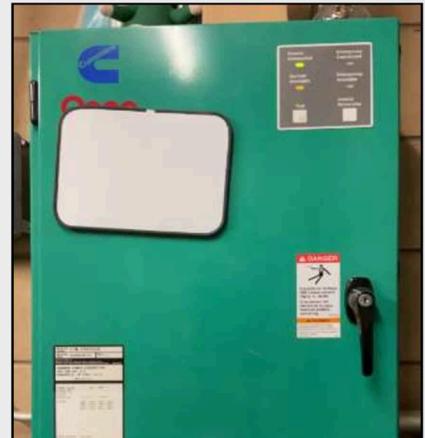
3. Replace the Backup Generator

The building's backup generator was installed in 2003 and has a capacity of 20 kW.

- Backup Generator (FCAID-370136)
- ATS (FCAID-370135)

Priority Level: 2
Estimated Cost: \$29,050
Remaining Life: 4-5 years

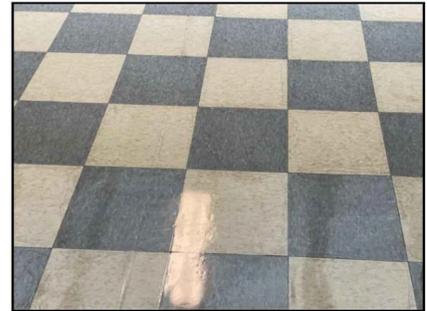
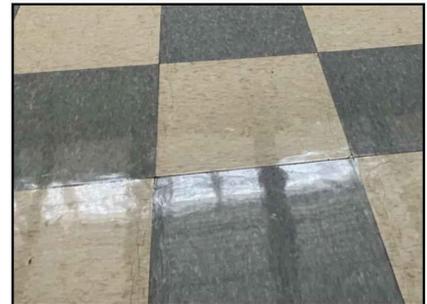
4. Replace the Cafeteria (FLEX) VCT Tiling

The VCT tiling in the cafeteria was found [REDACTED], with areas of cracking and peeling tiles identified. Plan to replace this surface in the next 3-5 years to reduce the risk of tripping hazards developing.

- Flooring - VCT (FCAID-370026)

Priority Level: 3
Estimated Cost: \$78,260
Remaining Life: 3-5 years

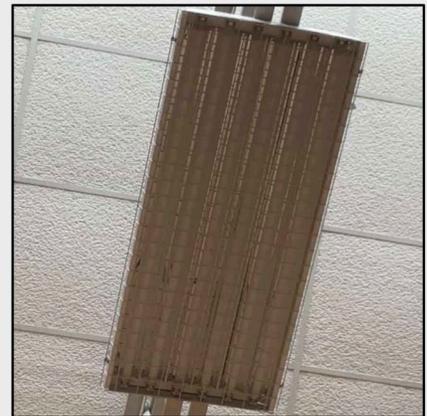
5. Replace Fluorescent Lighting

A portion of the building's interior lighting utilizes fluorescent (T8) technology. This includes the classroom spaces, corridors, and administrative areas. Consider replacing these fixtures with light emitting diode (LED) fixtures to reduce the building's energy costs and maintenance needs.

- Interior Lighting, Fluorescent (FCAID-370140)
