POUDRE SCHOOL
DISTRICT
BENNETT
ELEMENTARY
SCHOOL

FACILITY CONDITION ASSESSMENT

FORT COLLINS, CO

OCTOBER 2023

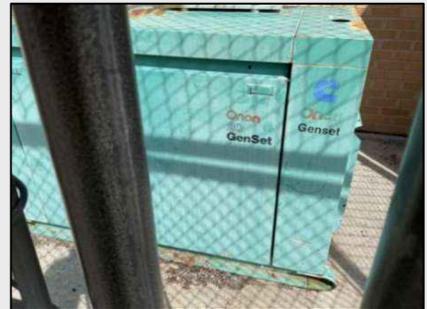
1. Replace Back-Up Generator & ATS-1

The back-up generator dates to 1994 [REDACTED]
Total Generator Run Hours = 506.5 . [REDACTED] The
associated ATS-1 (not located) is estimated to be 50A and built in 1994. [REDACTED]
[REDACTED]

Priority Level:	1
Estimated Cost:	\$22,630
Remaining Life:	1-2 Years

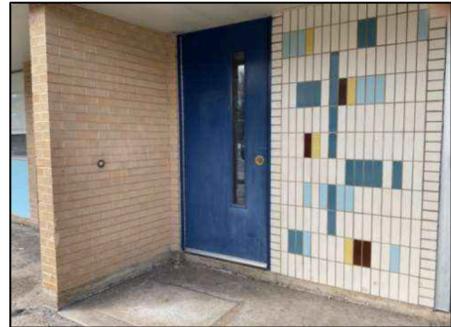
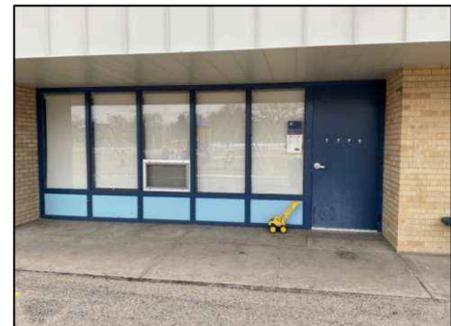
2. Replace 1960's Doors & Windows

There are (12) 1963-1966 exterior doors, and sections of 1963-1966 exterior metal framed windows remaining. [REDACTED]
Recommend replacement within the year.

Priority Level: 2
Estimated Cost: \$203,370
Remaining Life: one year

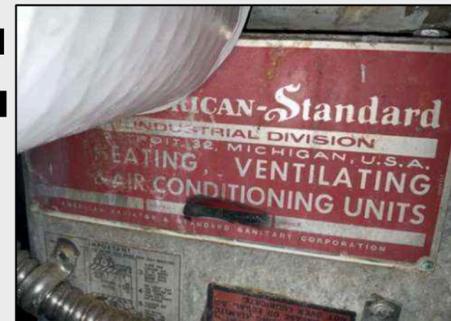
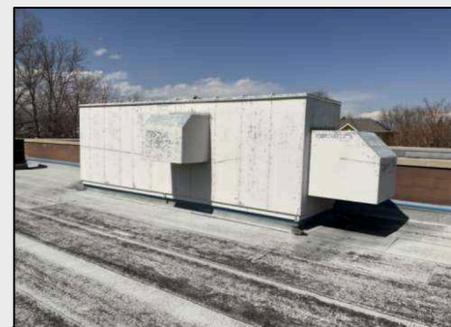
3. Replace AHU-1, RTU-3, RTU-4

AHU-1 is an original 1963-built unit serving the Gym. [REDACTED]
RTU-3 and RTU-4 are dated 1994 and 2002 respectively, but that may only indicate when they were updated. These two RTUs may be original 1963-built unit as well. [REDACTED]

Priority Level: 2
Estimated Cost: \$270,210
Remaining Life: 1-2 Years

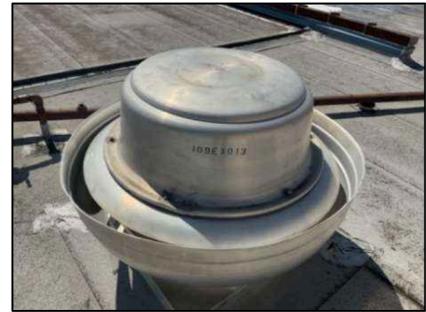
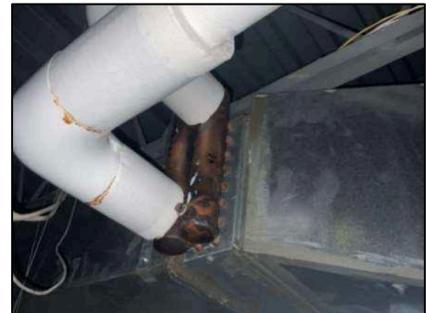
4. Replace BBRs, DHCs, Exhaust Fans, UVs

There are (18) 1994-built duct heating units, (29) 1994-built exhaust fans, and (7) 1963-built baseboard heaters remaining in this school. BBRs are 35 years past expected life, DHCs are 11 years past life, and Exhaust Fans are 9 years past life, and UVs 1 & 2 are 7 years past due.

Priority Level: 2
Estimated Cost: \$266,520
Remaining Life: 1-2 Years

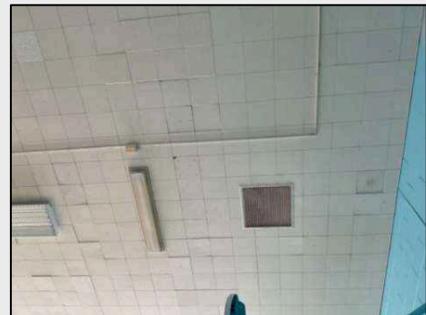
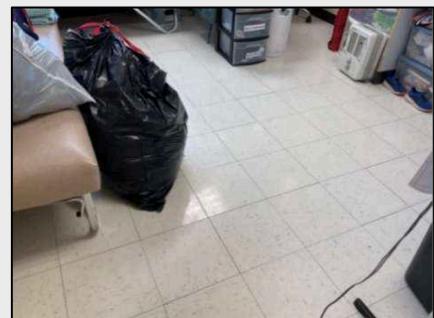
5. Replace carpet, acoustic tile, VCT

The building includes section of 1994 and 2002 carpeting, 1994 VCT flooring, and 1996 acoustical tile ceiling in the Gym (37 years past expected life). Recommend replacement of these dated interior finish assets in 1-2 years.

Priority Level: 2
Estimated Cost: \$712,580
Remaining Life: 1-2 Years
