# POUDRE SCHOOL DISTRICT

# IRISH ELEMENTARY SCHOOL

## FACILITY CONDITION ASSESSMENT

OCTOBER 2023

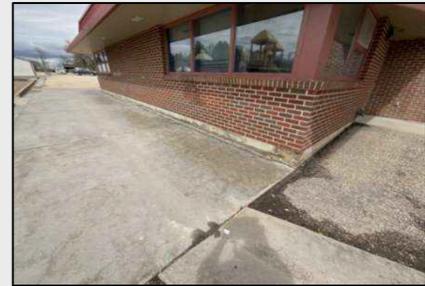
#### **Slab Foundation Repair**

Out of scope item (Foundation). The West Central 1989 exterior was observed to have [REDACTED] concrete slab spalling. Recommend immediate repair to this 25' section to prevent further water/weather damage.

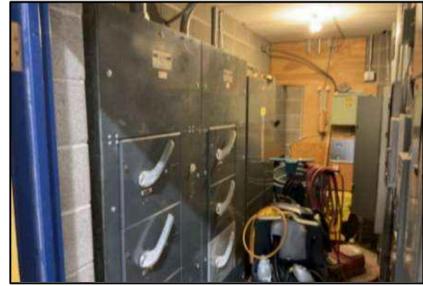
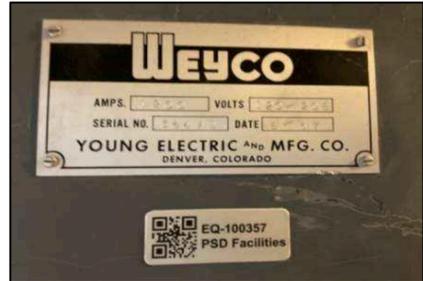
## Replace 1968 Switchboard & Panelboards

**Priority Level:** 1  
**Estimated Cost:** \$131,820  
**Remaining Life:** 1 Year

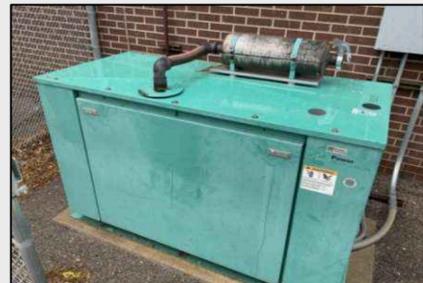
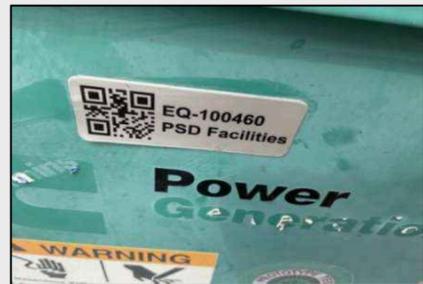
## Replace Back-Up Generator

Run Hours are fairly low at 221.1, but the overall condition is poor. The associated ATS was replaced in 2014 and does not require replacement.

**Priority Level:** 1  
**Estimated Cost:** \$51,270  
**Remaining Life:** 2 Years

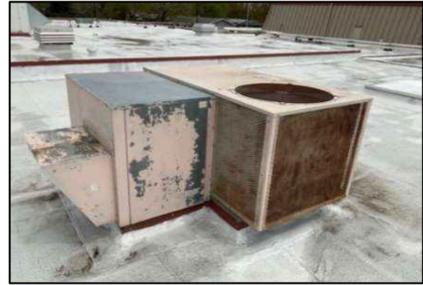
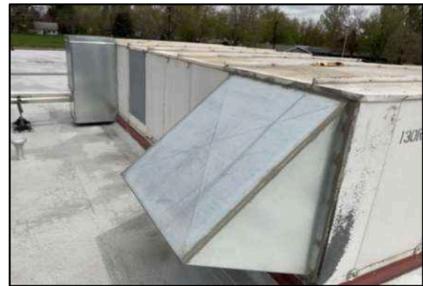
## Replace (6) Rooftop Units

Of the total eleven RTUs, five were replaced in 2014 but two (RTU-8 and RTU-9) date to 1989 and four (RTUs 2,3,4,5,) date to 1992.

**Priority Level:** 2  
**Estimated Cost:** \$253,480  
**Remaining Life:** 1-2 Years

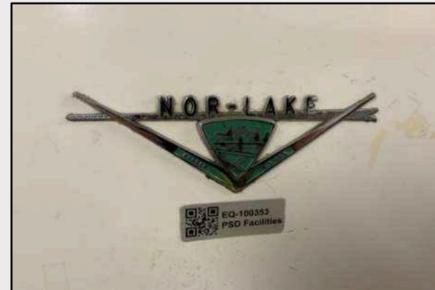
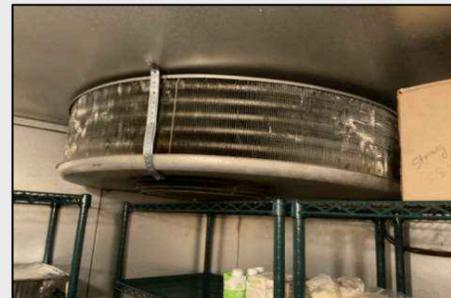
## Replace Walk-In Cooler

The Walk-In Cooler is original 1968 construction and is 35 years past expected life. Expect to replace the Walk-In Cooler within the year.

**Priority Level:** 2  
**Estimated Cost:** \$12,060  
**Remaining Life:** 1 Year
