POUDRE SCHOOL
DISTRICT
LINTON
ELEMENTARY
SCHOOL

FACILITY CONDITION ASSESSMENT

FORT COLLINS, CO

OCTOBER 2023

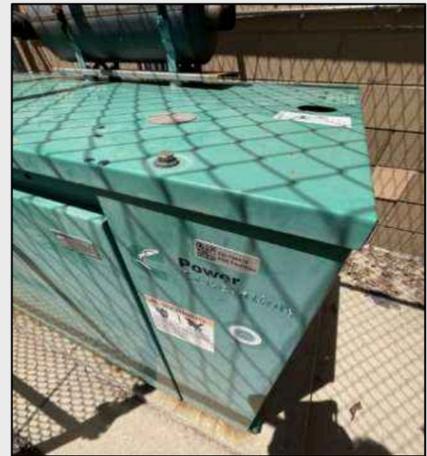
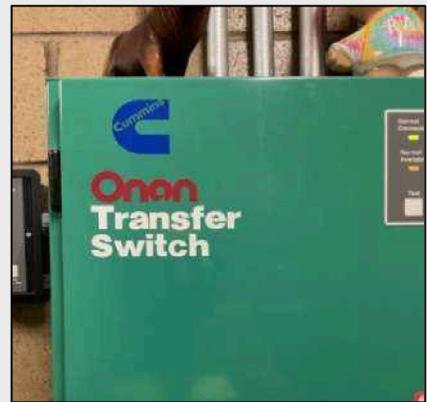
Replace Back-Up Generator & ATS-1

The back-up generator and ATS-1 are original to the 1988 construction and are now 15 and 10 years past expected life respectively. [REDACTED]

Priority Level:	2
Estimated Cost:	\$57,660
Remaining Life:	1-4 years

[REDACTED]. Recommend replacement of both assets at the same time.

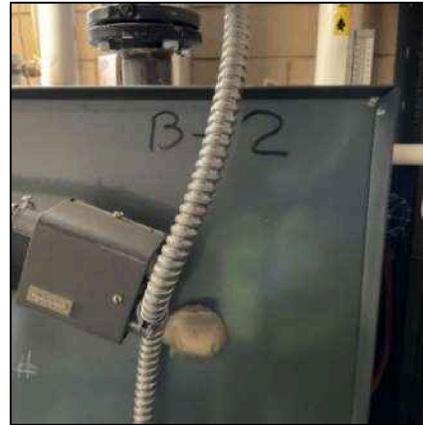
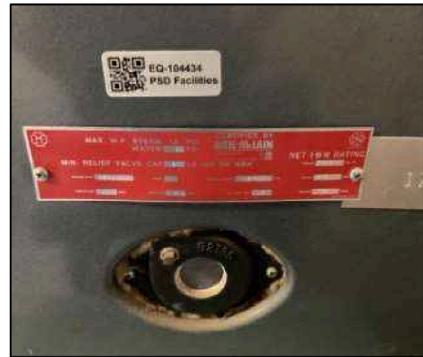
Replace Boiler-2

Though Boiler-1 was replaced in 2020 and is in good condition, [REDACTED] [REDACTED]. Recommend replacement prior to 2024-2025 heating season.

Priority Level: 2
Estimated Cost: \$78,630
Remaining Life: 1 year

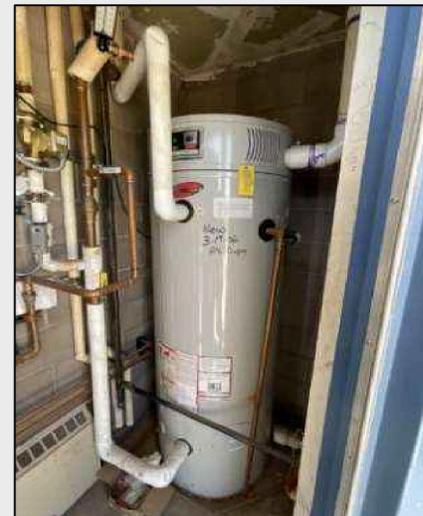
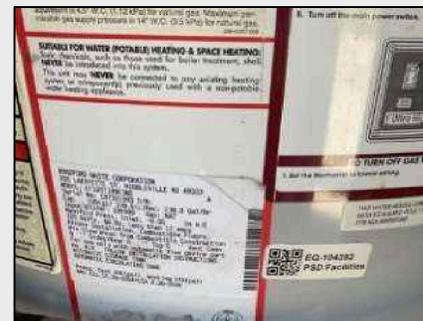
Replace (3) GWHs

GWH-1, GWH-2, and GWH-3 date to between 2003 and 2005 and are expected to require replacement in approximately 2 years.

Priority Level: 2
Estimated Cost: \$28,950
Remaining Life: 2 years

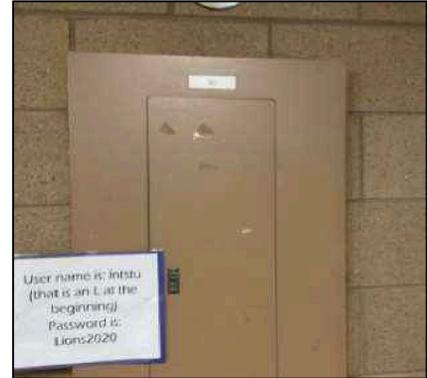
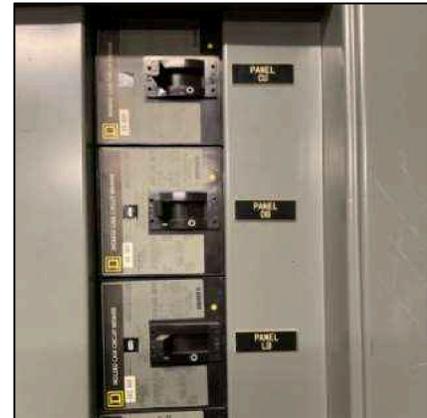
Replace 1988 Electrical Assets

Though not an immediate concern, there exist (12) panelboards, a switchboard, and the pad transformer that date to 1988. These assets are expected to require replacement in approximately 5 years and will represent a substantial Replacement Cost at that time. Item added for Capital Planning.

Priority Level: 3
Estimated Cost: \$85,680
Remaining Life: 5 years

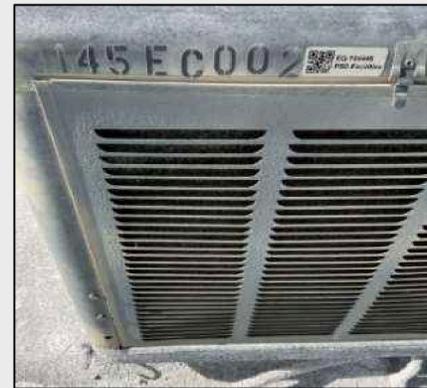
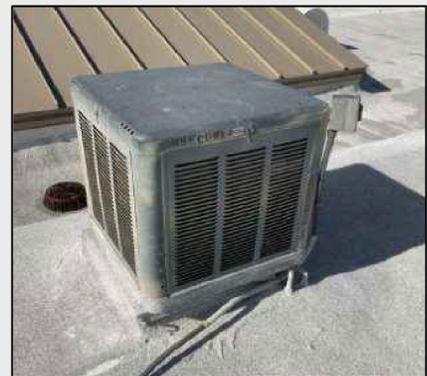
Replace EC-1

EC-1 (145EC002 Evap Cooler) is 10 years past expected useful life [REDACTED] Recommend replacement in 1-2 years.

Priority Level: 3
Estimated Cost: \$2,500
Remaining Life: 1-2 years
