POUDRE SCHOOL
DISTRICT
EYESTONE
ELEMENTARY
SCHOOL SOUTH

FACILITY CONDITION ASSESSMENT

WELLINGTON, CO

OCTOBER 2023

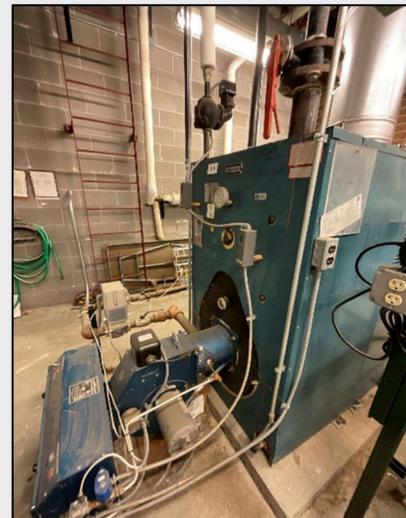
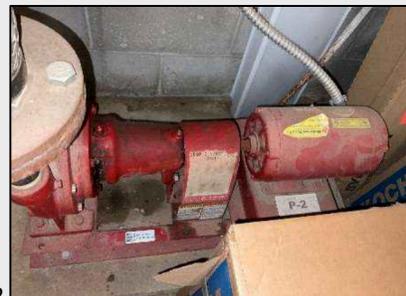
Replace Boilers and Hot Water Pumps

B-1 was installed in 1993 and is nearing the end of its life expectancy. B-2 was installed in 1984 and has surpassed the end of its life expectancy. [REDACTED]

[REDACTED] Additionally, hot water pumps P-1 and P-2 should be replaced within the next year given [REDACTED]

Priority Level: 2
Estimated Cost: \$198,630
Remaining Life: 1-5 years

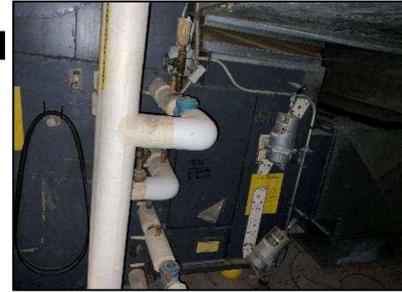
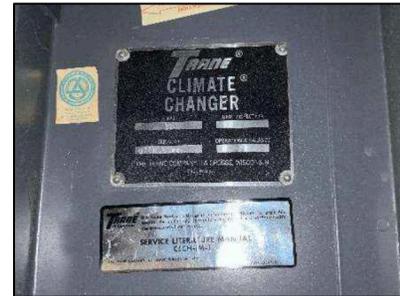
Replace Air Handling Units

The three air handling units serving the locker rooms and gym [REDACTED] These units are estimated to have surpassed their industry life expectancies. It is recommended that these three units be replaced within the next two years.

Priority Level: 2
Estimated Cost: \$533,260
Remaining Life: 2 years

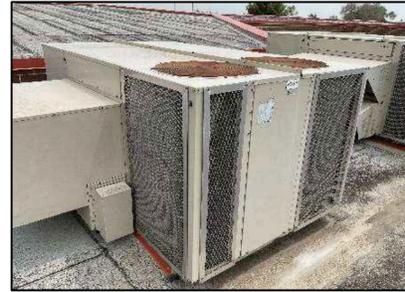
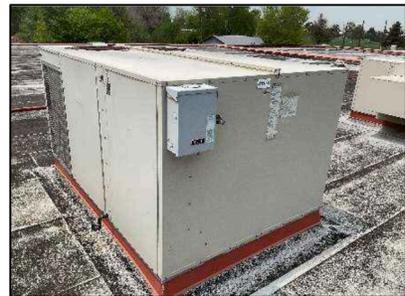
Replace Rooftop Units

The nine rooftop units installed in 1993, serving various areas including classrooms, labs, media center, and the multipurpose room, [REDACTED] These units have surpassed their industry life expectancies by approximately 15 years [REDACTED]

[REDACTED] It is recommended that these nine units be replaced within the next two years.

Priority Level: 2
Estimated Cost: \$438,360
Remaining Life: 2 year
