POUDRE SCHOOL
DISTRICT
BEATTIE
ELEMENTARY
SCHOOL

FACILITY CONDITION ASSESSMENT

FORT COLLINS, CO

OCTOBER 2023

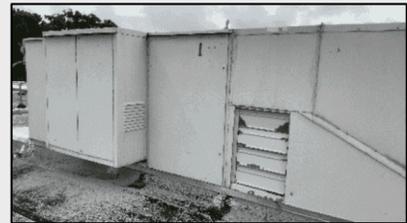
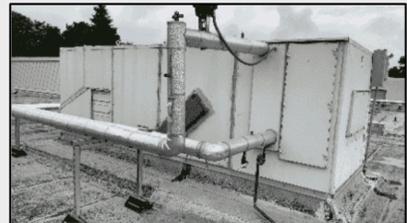
Replace Rooftop Units

Seven of the rooftop units [REDACTED] have surpassed their life expectancies and should be replaced within the next three years.

Priority Level:	2
Estimated Cost:	\$801,820
Remaining Life:	3 years

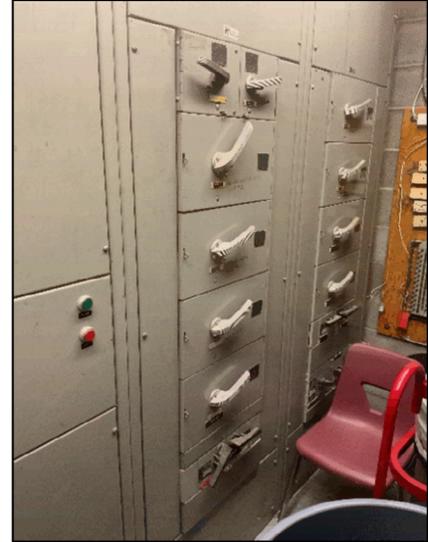
Replace Switchboard

The three-section switchboard was installed in 1972 [REDACTED]. This asset has surpassed its life expectancy by over 10 years and should be replaced within the next four years.

Priority Level: 2
Estimated Cost: \$160,720
Remaining Life: 4 years

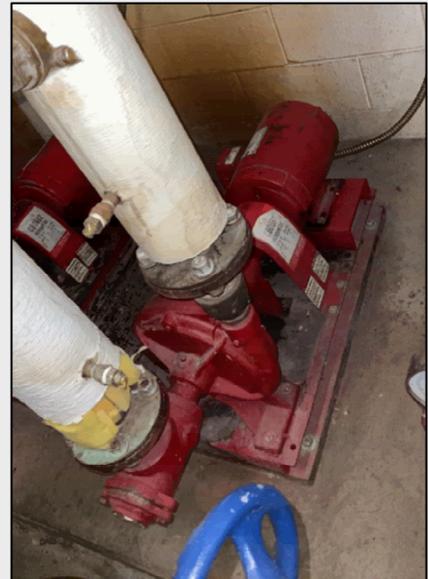
Replace Hot Water Pumps

The two hot water pumps were installed in 1997 have surpassed their industry life expectancy and should be replaced in three years.

Priority Level: 2
Estimated Cost: \$23,440
Remaining Life: 3 years

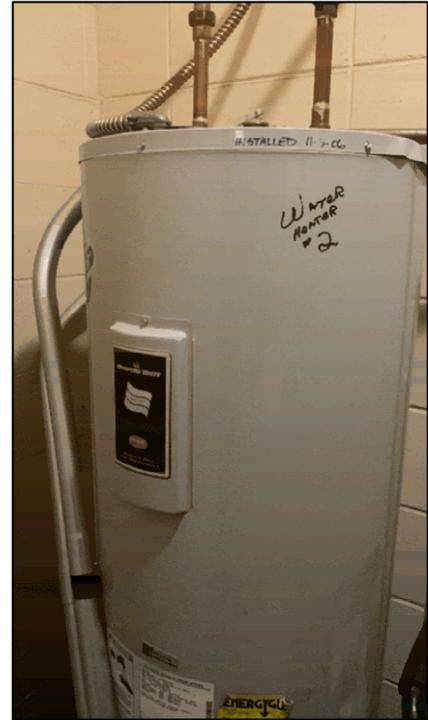
Replace Water Heaters

The three water heaters installed before 2010 have surpassed their life expectancies and are anticipated to need replacement within the next three years.

Priority Level: 2
Estimated Cost: \$18,660
Remaining Life: 3 years

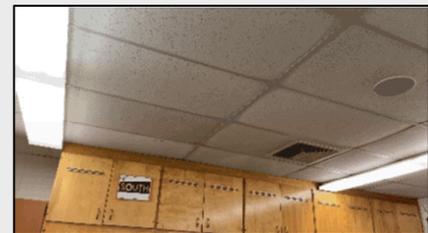
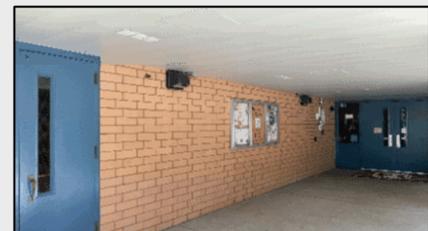
Replace Lighting Fixtures

Interior lighting consists of fluorescent fixtures, which were retrofitted in 2002 and just past their industry life expectancy. Exterior lighting is made up of incandescent lights [REDACTED]. Consider upgrading the interior and exterior lighting to light emitting diode (LED) fixtures to reduce energy costs and maintenance needs.

Priority Level: 2
Estimated Cost: \$887,610
Remaining Life: 3-5 years
