POUDRE SCHOOL  
DISTRICT  
STOVE PRAIRIE  
ELEMETNARY  
SCHOOL

FACILITY CONDITION ASSESSMENT

BELLVUE, CO

OCTOBER 2023

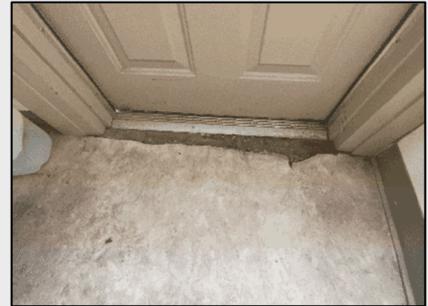
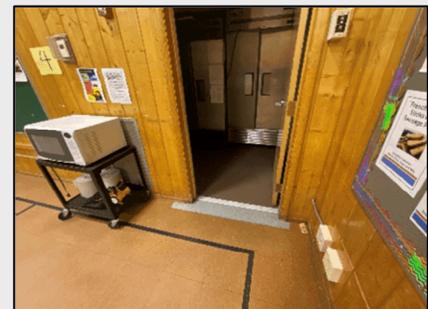
##### Replace VCT Flooring

The VCT flooring, including tiles and sheet vinyl, has surpassed its industry life expectancy and is in poor condition. It is recommended that these flooring finishes are replaced within the next two years.

FCAID-540025, FCAID-540026

<b>Priority Level:</b>	2
<b>Estimated Cost:</b>	\$15,600
<b>Remaining Life:</b>	2 years

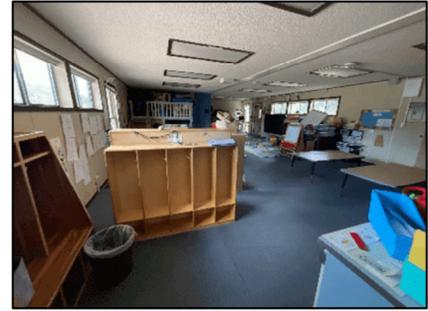
## Replace Carpeting

The areas of carpeting installed in 1998 have surpassed their useful life by approximately 15 years. The carpet in these areas are in poor condition and should be replaced within the next two years.

FCAID-540019

**Priority Level:** 2  
**Estimated Cost:** \$8,950  
**Remaining Life:** 2 years

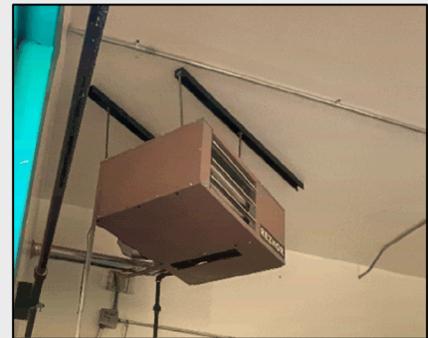
## Replace Gas Unit Heater

The gas unit heater serving the facilities room has surpassed its life expectancy and should be replaced within the next three years.

FCAID-540043

**Priority Level:** 2  
**Estimated Cost:** \$3,520  
**Remaining Life:** 3 years

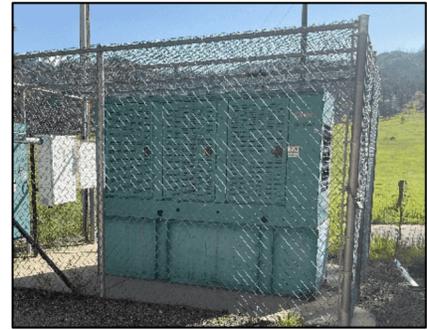
## Replace Emergency Generator

The emergency generator [REDACTED] and should be replaced within four years.

FCAID-540045

**Priority Level:** 2  
**Estimated Cost:** \$84,580  
**Remaining Life:** 4 years

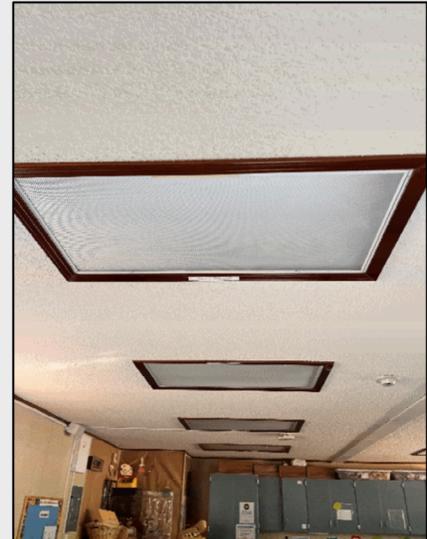
## Replace Lighting Fixtures

Interior lighting consists of mostly fluorescent fixtures which are estimated to have been installed in 2006 and are nearing the end of their life expectancy. Consider upgrading the interior and exterior lighting to light emitting diode (LED) fixtures to reduce energy costs and maintenance needs.

FCAID-540050

**Priority Level:** 3  
**Estimated Cost:** \$94,770  
**Remaining Life:** 3 years
