POUDRE SCHOOL
DISTRICT
TAVELLI
ELEMENTARY
SCHOOL

FACILITY CONDITION ASSESSMENT

FORT COLLINS, CO

OCTOBER 2023

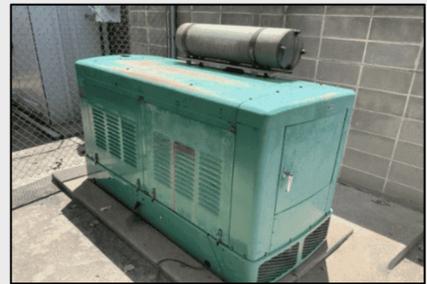
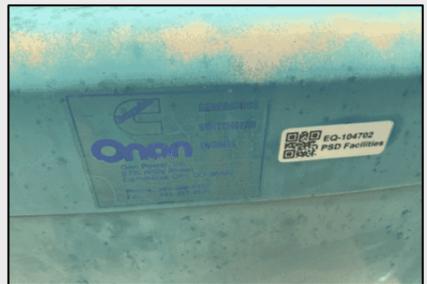
Replace Back-Up Generator

The Generator dates to 1993 and is 10 years past expected life. Run Hours = 519.1 . Recommend replacement within two years. [REDACTED]

Priority Level:	1
Estimated Cost:	\$51,270
Remaining Life:	1-2 Years

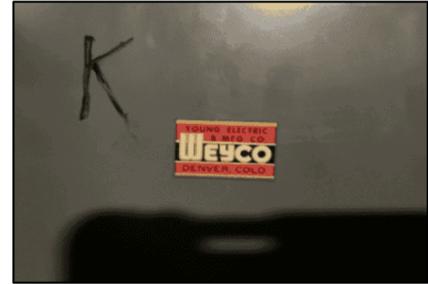
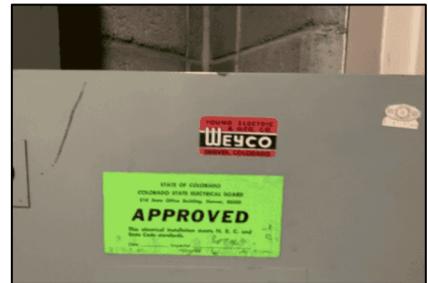
Replace (4) 1968 Panelboards

Panels K, PA, PB, and PD date to 1968 and are 15 years past expected life. [REDACTED]
[REDACTED] Replace within the year.

Priority Level: 2
Estimated Cost: \$31,280
Remaining Life: one year

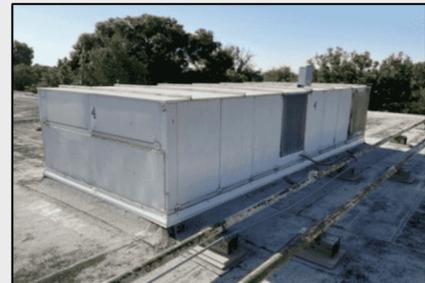
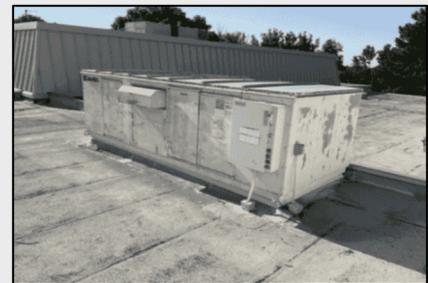
Replace RTUs 4,5,6,7

RTU-5 and RTU-6 date to 1993 [REDACTED] RTU-4 and RTU-7 date to 1995 [REDACTED] These RTUs are 13-15 years past expected life. Replace in 1-2 years.

Priority Level: 2
Estimated Cost: \$195,880
Remaining Life: 1-2 Years

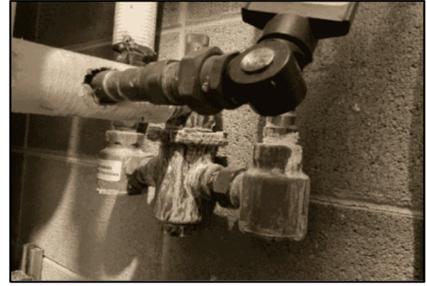
Replace Thermostatic Mixing Valve

Though the thermostatic mixing valve was replaced in 2017 [REDACTED] and needs to be replaced within the year.

Priority Level: 2
Estimated Cost: \$3,110
Remaining Life: one year
