POUDRE SCHOOL  
DISTRICT  
BAMFORD  
ELEMENTARY  
SCHOOL

FACILITY CONDITION ASSESSMENT

LOVELAND, CO

OCTOBER 2023

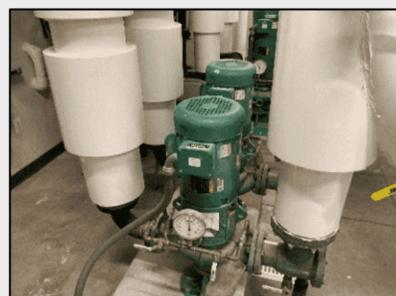
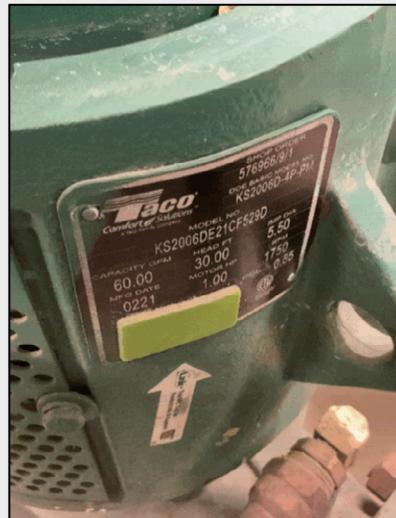
#### Ground Source Loop Pump Sizing

It was observed that several pumps that were installed to serve the ground source loop varied from the sizing originally intended per design and specifications. This is a top issue at Bamford Elementary School as these sizing discrepancies could present issues in the proper functioning of the ground source loop system.

FCAID-020044, FCAID-020045, FCAID-020046, FCAID-020047, FCAID-020051, FCAID-020052, FCAID-020053, FCAID-020054

Priority Level: 2  
Estimated Cost: \$104,360  
Remaining Life: N/A

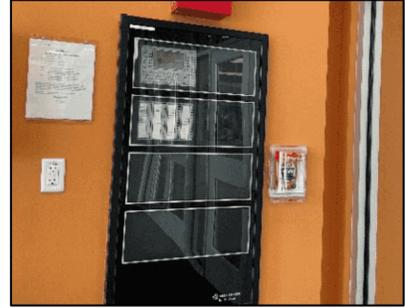
## Replace Fire Alarm System

The fire alarm system was installed when Bamford Elementary School was built in 2022, however, given that it is a high-priority asset with a shorter industry life expectancy it is a top issue that will need to be replaced sooner than other equipment at the school.

FCAID-020190

<b>Priority Level:</b>	3
<b>Estimated Cost:</b>	\$584,250
<b>Remaining Life:</b>	14 Years
