POUDRE SCHOOL
DISTRICT

POUDRE COMMUNITY
ACADEMY HIGH
SCHOOL

FACILITY CONDITION ASSESSMENT

OCTOBER 2023

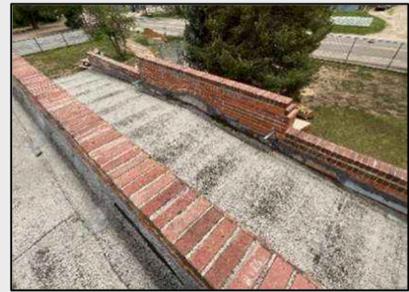
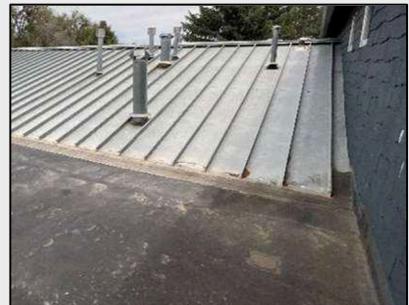
Replace Rolled Asphalt and Sheet Metal Roofing

Both the rolled asphalt and sheet metal roofing [REDACTED] have surpassed their industry life expectancies. Rolled asphalt roofing material is bubbled up and has visible cracks. The sheet metal roofing material is showing signs of deterioration. Roofing should be replaced within the next year.

FCAID-430022, FCAID-430023

Priority Level:	2
Estimated Cost:	\$32,820
Remaining Life:	1 Year

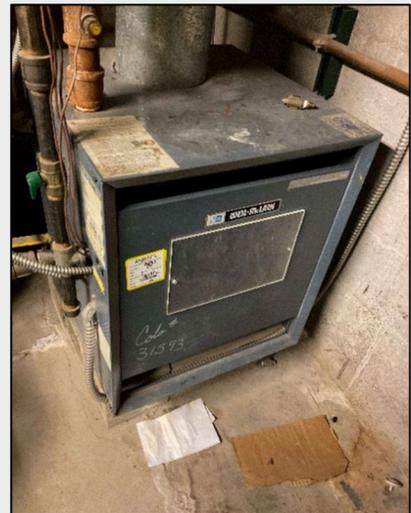
Replace Boiler

The boiler was installed in 1991 [REDACTED] is nearing the end of its life expectancy and is anticipated to need replacement within the next three years.

FCAID-430064

Priority Level: 2
Estimated Cost: \$37,000
Remaining Life: 3 Years

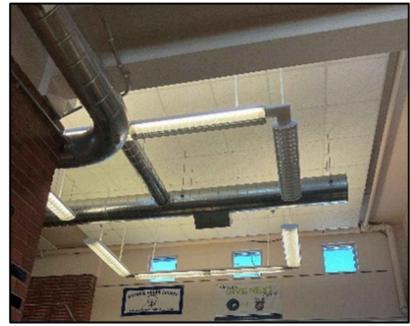
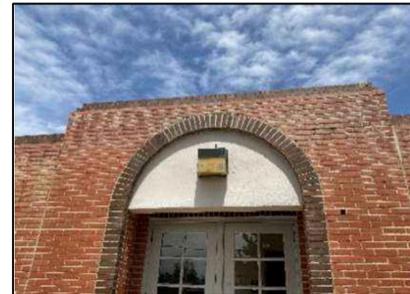
Upgrade Interior Fluorescent and Exterior Incandescent Lighting

Interior lighting mostly consists of fluorescent lighting retrofitted in 2005. These fixtures will reach the end of their industry life expectancy within two years. Exterior lighting is made up, in part, of incandescent and fluorescent fixtures that [REDACTED] should be replaced [REDACTED]. Consider upgrading the interior and exterior lighting to LED fixtures to reduce energy costs and maintenance needs.

FCAID-430075, FCAID-430076, FCAID-430077, FCAID-430079

Priority Level: 3
Estimated Cost: \$312,600
Remaining Life: 2 Years

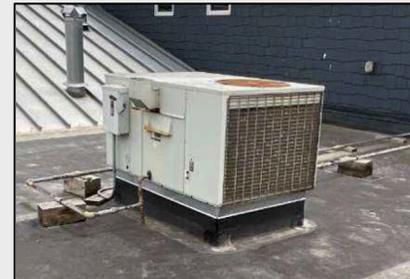
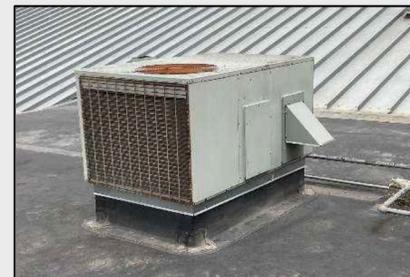
Replace RTU-1

RTU-1 [REDACTED] is estimated to have surpassed its life expectancy, and is anticipated to need replacement within the next two years.

FCAID-430071

Priority Level: 2
Estimated Cost: \$24,560
Remaining Life: 2 Years
