POUDRE SCHOOL DISTRICT POUDRE HIGH SCHOOL

FACILITY CONDITION ASSESSMENT

FORT COLLINS, CO

OCTOBER 2023

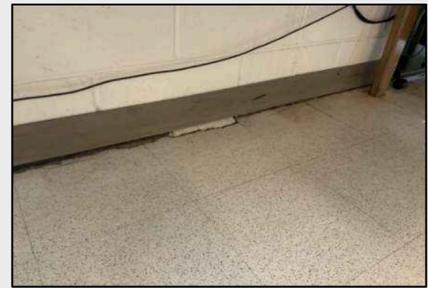
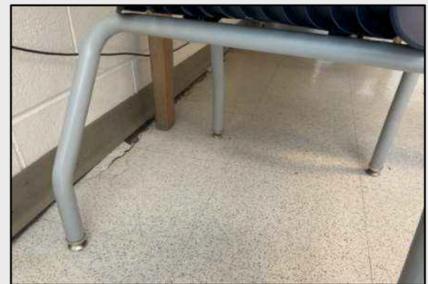
Foundation Subsidence - Wall & Floor Damage

Limited foundational Subsidence was observed in classrooms 312 and 314; the concrete floors are separating from the CMU wall. Gaps were also observed in the CMU walls. Interior finish assets have been damaged due to sub-flooring subsidence.

Priority Level:	1
Estimated Cost:	TBD
Remaining Life:	N/A

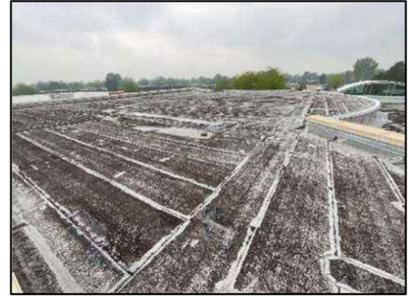
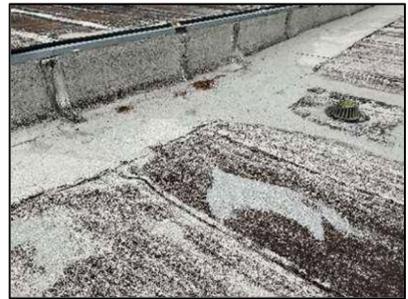
FCAID-440033

Replace Rolled Asphalt Roofing

The rolled asphalt roofing installed in 1996 [REDACTED] has surpassed its industry life expectancy. Rolled asphalt roofing material is bubbled up and has lots of standing water and moss. These areas of roofing should be replaced within the next year.

Priority Level: 2
Estimated Cost: \$1,559,400
Remaining Life: 1 Year

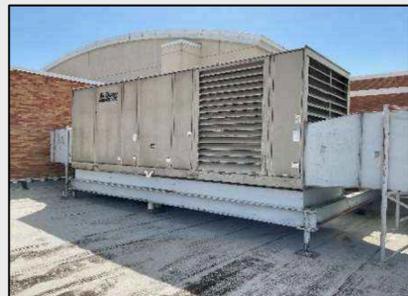
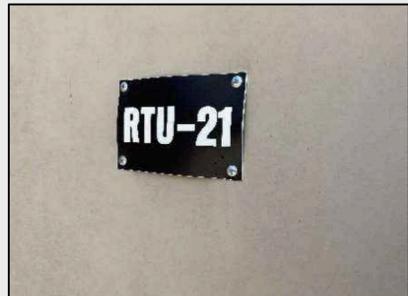
FCAID-440216

Replace RTU-21

RTU-21 was installed in 1994 and has surpassed its industry life expectancy. This unit serves the main gym [REDACTED]. It is recommended that this unit be replaced within the next three years.

Priority Level: 2
Estimated Cost: \$639,900
Remaining Life: 3 Years

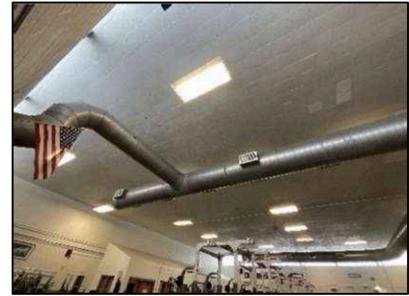
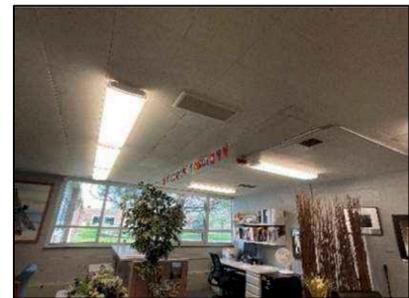
FCAID-440058

Replace 1962 Acoustic Ceiling Tile

The acoustic ceiling tile installed during original construction in 1962 [REDACTED] [REDACTED] [REDACTED] should be replaced within the next year.

Priority Level: 1
Estimated Cost: \$25,590
Remaining Life: 1 Year

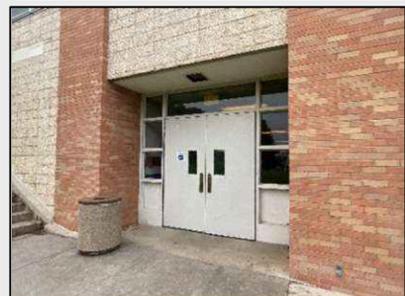
FCAID-440023, FCAID-440026

Replace 1962 Exterior Windows

Priority Level: 2
Estimated Cost: \$691,170
Remaining Life: 2 Years
