# POUDRE SCHOOL DISTRICT CENTENNIAL HIGH SCHOOL

## FACILITY CONDITION ASSESSMENT

FORT COLLINS, CO

OCTOBER 2023

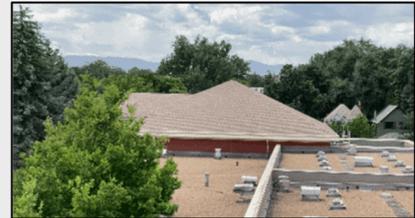
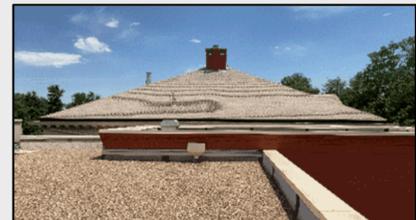
#### Asphalt Shingle Replacement

Both the East and West buildings have sloped roofs with Asphalt Shingles. These shingles are reaching the end of their designed lifespans and replacement should be considered in the near future.

FCAID - 150023, FCA - 150024

<b>Priority Level:</b>	3
<b>Estimated Cost:</b>	\$127,090
<b>Remaining Life:</b>	1 Year

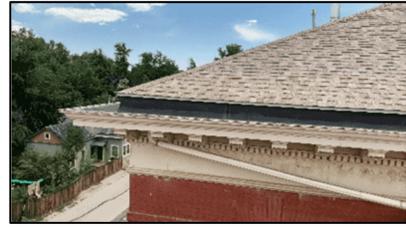
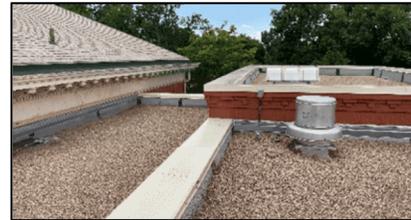
As part of the original roof design, an internal gutter was installed. It is presumed that as part of the latest re-roofing (with asphalt shingles) the flashing of this internal gutter was reviewed, repaired, and updated. As part of the re-roofing of the asphalt shingles (due to their lifespan) the internal gutter should once again be reviewed and repaired as needed. (similar to the adjacent Asphalt Shingles)

FCAID - 150020

**Priority Level:** 3  
**Estimated Cost:** TBD  
**Remaining Life:** 1 Year

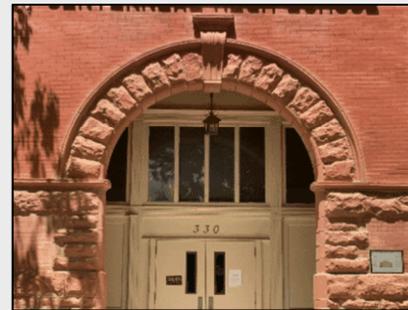
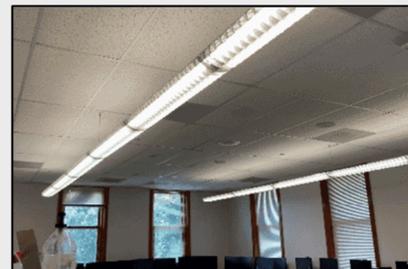
## Upgrade Interior and Exterior Lighting

FCAID-150144, FCAID-150179

**Priority Level:** 2  
**Estimated Cost:** \$393,630  
**Remaining Life:** 10 Years

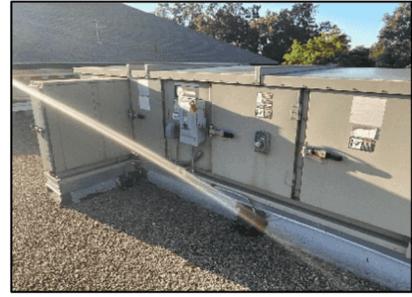
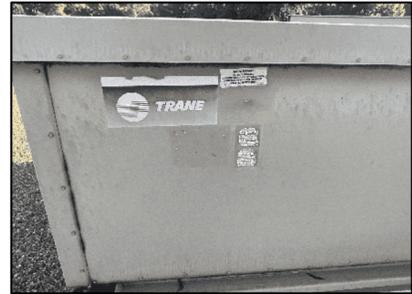
## Replace Rooftop Units

The five rooftop units were installed in 2003, [REDACTED] have surpassed their life expectancies, and should be replaced within the next five years.

FCAID-150133, FCAID-150134, FCAID-150135, FCAID-150136, FCAID-150137

**Priority Level:** 2  
**Estimated Cost:** \$385,620  
**Remaining Life:** 5 Years

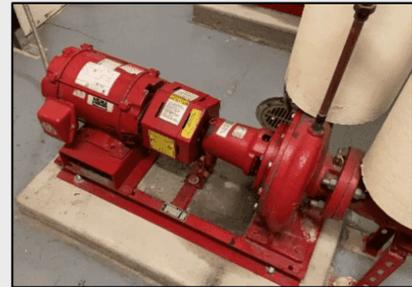
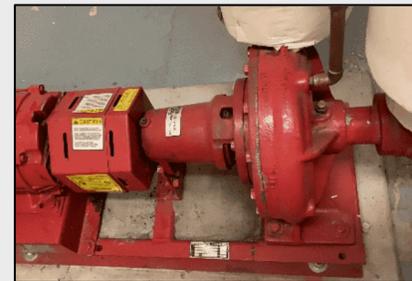
## Replace Hot Water Pumps

The hot water pumps have reached the end of their life expectancy and are anticipated to need to be replaced within the next four years.

FCAID-150099, FCAID-150100, FCAID-150101, FCAID-150102

**Priority Level:** 2  
**Estimated Cost:** \$47,600  
**Remaining Life:** 4 Years
