POUDRE SCHOOL
DISTRICT
BLEVINS MIDDLE
SCHOOL

FACILITY CONDITION ASSESSMENT

FORT COLLINS, CO

OCTOBER 2023

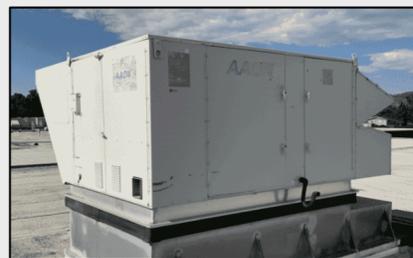
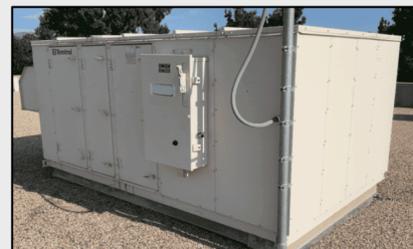
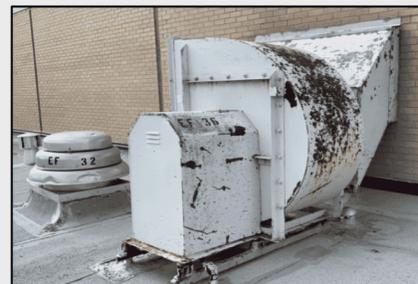
1. Replace Outdated Ventilation Equipment

Several of the building's air handling and exhaust assets have greatly exceeded their industry recommended lifespan, [REDACTED]. This includes the gymnasium air handler, as well as the rooftop exhaust fans. [REDACTED]

- HVU-1 (FCAID-050129)
- RTU-7 (FCAID-050149)
- Kiln Hood (FCAID-050133)
- (33) Rooftop Exhaust Fans (FCAIDs vary)

Priority Level: 2
Estimated Cost: \$382,170
Remaining Life: 2-5 years

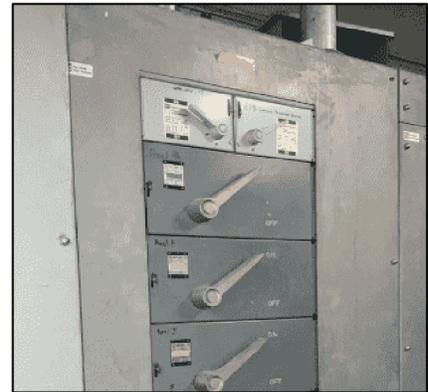
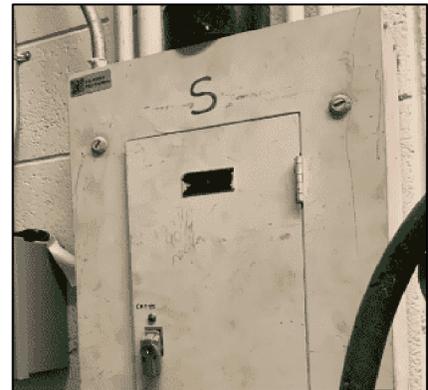
2. Replace Outdated Electrical Assets

While the majority of the building's electrical distribution assets have been replaced within the last 10-15 years, a handful of switchgear and panels appear to date back to the building's original 1967 construction. [REDACTED] plan to replace them within the next 4 years.

- Main Switchgear, Section 1 (FCAID-050223)
- Main Switchgear, Section 2 (FCAID-050224)
- Main Switchgear, Section 3 (FCAID-050225)
- Panel S (FCAID-050247)

Priority Level: 2
Estimated Cost: \$140,080
Remaining Life: 4 years

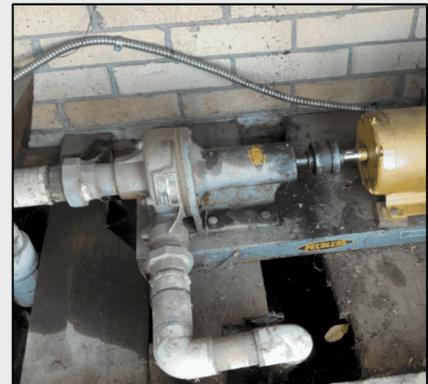
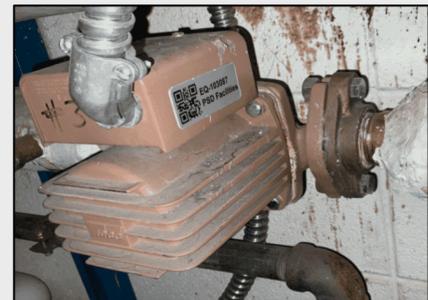
3. Replace Outdated Plumbing Assets

Several assets serving the domestic hot water supply system have reached the end of their lifespan, and will be due for replacement within the next 2-5 years. [REDACTED]

- DHW Pump P-3 (FCAID-050039)
- DHW Pump P-4 (FCAID-050040)
- Irrigation Pump (FCAID-050043)
- Backflow Preventer (FCAID-050037)
- Fire Suppression Backflow Preventer (FCAID-050042)
- Main Backflow Preventer (FCAID-050044)
- DHW Mixing Valve (FCAID-050038)

Priority Level: 3
Estimated Cost: \$28,250
Remaining Life: 2-5 years

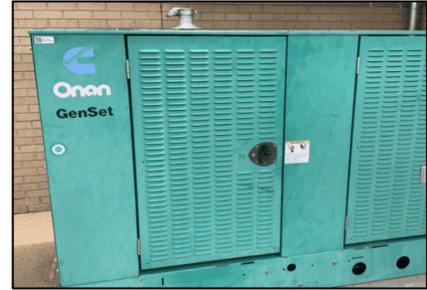
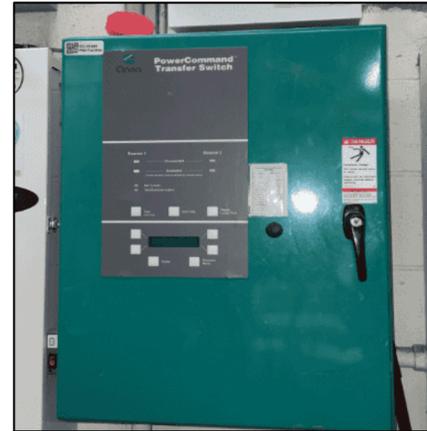
4. Replace the Generator

The building's backup generator was installed in 2001, and [REDACTED] it has reached the end of its industry recommended lifespan. [REDACTED]

- Backup Generator (FCAID-050216)
- ATS (FCAID-050215)

Priority Level: 3
Estimated Cost: \$37,770
Remaining Life: 5 years

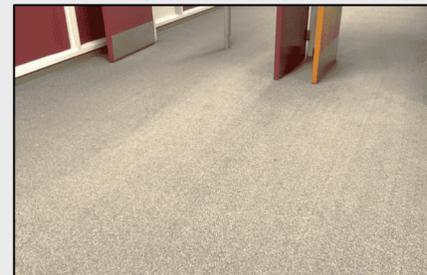
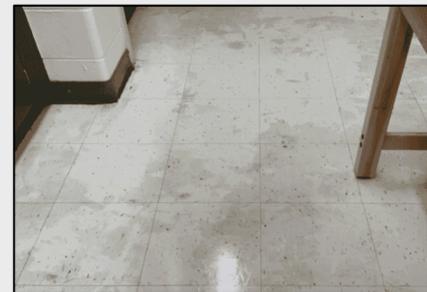
5. Update Interior Finishes

While the majority of the building's interior finishes are in good condition, areas of the building's carpeting and vinyl tiling are in poor condition. These areas are worn due to traffic, and can present tripping hazards especially for damaged vinyl tiles. Plan to replace heavily worn areas within 5 years. Note, the replacement cost shown below includes a full replacement of these systems which will likely not be necessary.

- Carpeting (FCAID-050024)
- VCT Flooring, Classrooms (FCAID-050031)

Priority Level: 3
Estimated Cost: \$914,100
Remaining Life: 5 years
