POUDRE SCHOOL DISTRICT PRESTON MIDDLE SCHOOL

FACILITY CONDITION ASSESSMENT

FORT COLLINS, CO

OCTOBER 2023

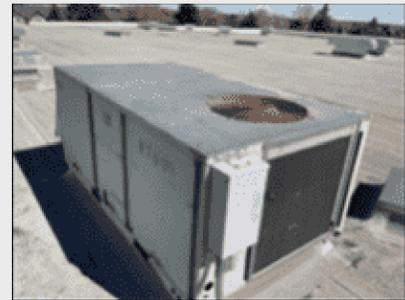
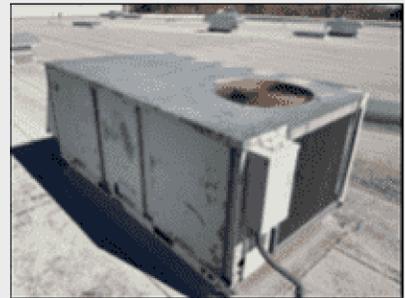
1. Replace Rooftop Units

RTUs 01 through 08 are original to the 1994 construction. All eight are now 14 years past expected useful life. RTU-05 and RTU-07 are [REDACTED] requiring replacement within the year. RTUs 01,02,03,04,06, and 08 are [REDACTED] requiring replacement within two years.

Priority Level:	2
Estimated Cost:	\$371,800
Remaining Life:	1-2 Years

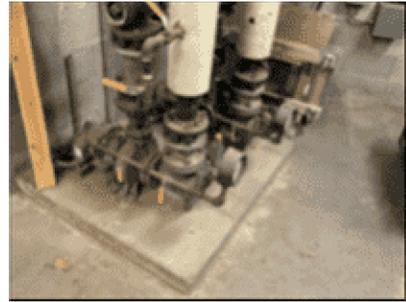
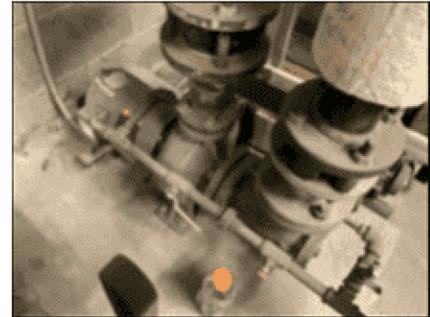
2. Heating Water Pumps Replacement

Heating Water System Pumps P-1, P-2, P-3, and P-4 are original to the 1994 construction. All four pumps are now 9 years past expected useful life. P-3 and P-4 are [REDACTED] requiring replacement within the year. P-1 and P-2 are [REDACTED] requiring replacement within two years.

Priority Level: 2
Estimated Cost: \$42,980
Remaining Life: 1-2 Years

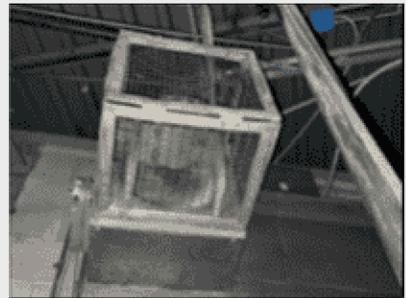
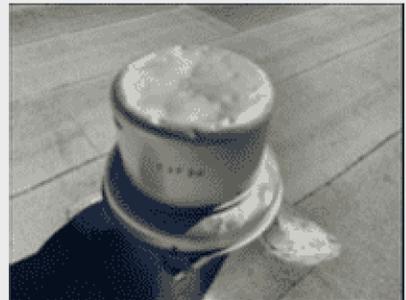
3. Exhaust Fan Replacements

EF-01 through EF-39 (28 EFs total) are original to the 1994 construction. These EFs are now 9 years past expected useful life. All 28 EFs have sustained substantial hail damage. EF-01 and EF-02 are [REDACTED], requiring replacement within the year. The remaining 26 EFs are [REDACTED], requiring replacement within two years.

Priority Level: 2
Estimated Cost: \$208,790
Remaining Life: 1-2 Years

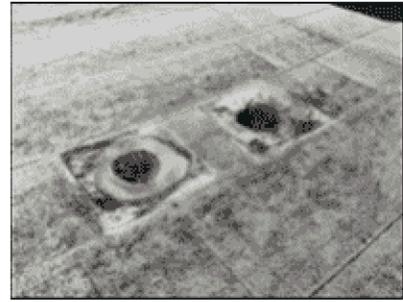
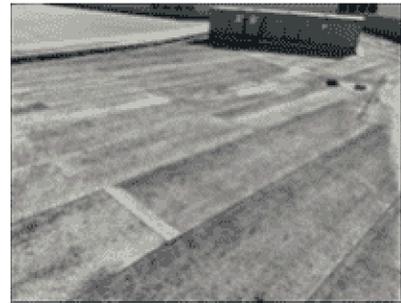
4. Replace Rolled Asphalt Roofing

The 1994 original rolled asphalt roof is now four years past expected useful life [REDACTED] [REDACTED] Roofing material is bubbled up and has visible cracks. Recommend replacement of the 1994 original rolled asphalt roof within two years.

Priority Level: 2
Estimated Cost: \$710,580
Remaining Life: 2 Years

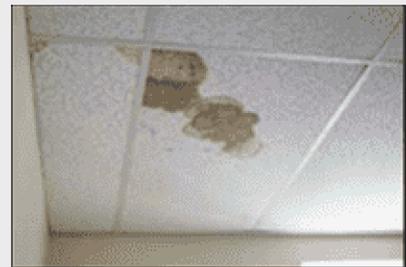
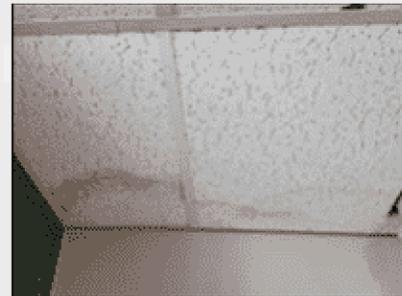
5. Replace Acoustical Tile Ceiling

The 1994 original acoustical ceiling panels are now 10 years past expected useful life [REDACTED] Multiple water leaks were observed. Recommend replacement of the 1994 original acoustical ceiling panels within two years.

Priority Level: 2
Estimated Cost: \$1,004,530
Remaining Life: 2 Years
