POUDRE SCHOOL DISTRICT KINARD MIDDLE SCHOOL

FACILITY CONDITION ASSESSMENT

FORT COLLINS, CO

OCTOBER 2023

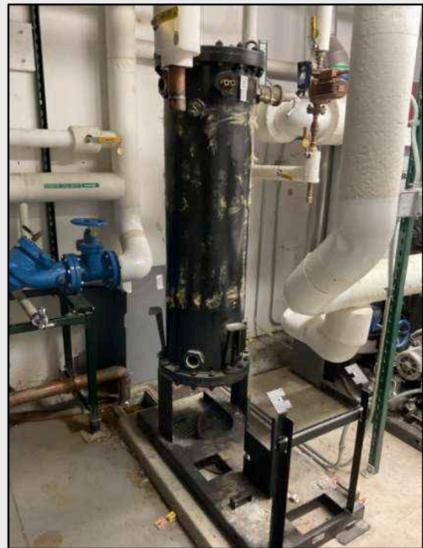
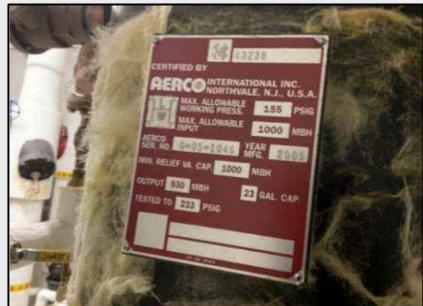
Replace Boiler-3

Boiler-3 was observed to be [REDACTED] in preparation for replacement. Recommend completion of boiler replacement prior to 2024-2025 heating season.

Priority Level: 1
Estimated Cost: \$78,630
Remaining Life: 1 Year

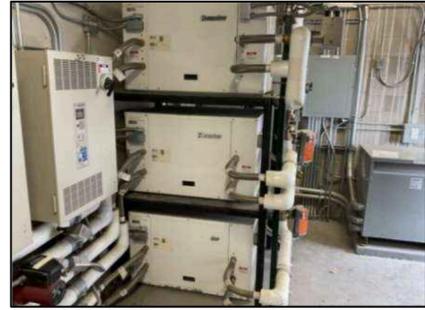
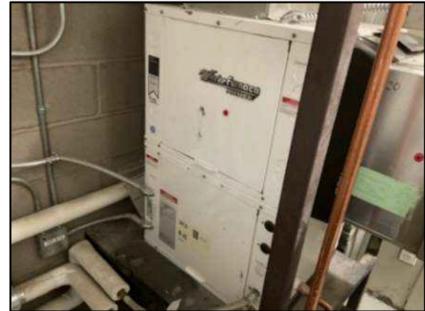
Replace (73) Ground-Source Heat Pumps

The (73) original 2006-built ground source heat pumps are now two years past expected life and are estimated to require replacement within in three years. [REDACTED] This measure is a high priority as replacement of (73) heat pumps constitutes a significant Capital Expenditure.

Priority Level: 2
Estimated Cost: \$860,480
Remaining Life: 3 Years

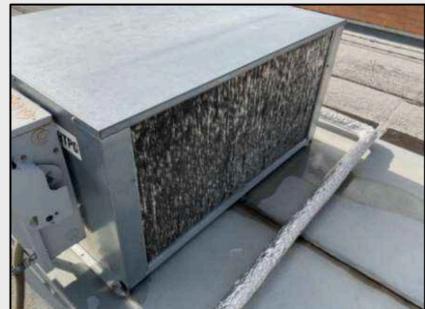
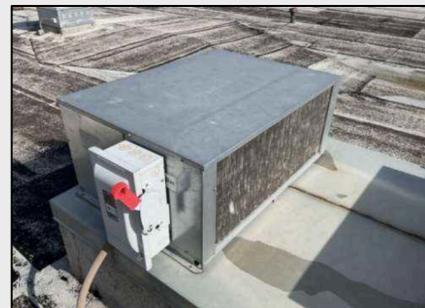
Replace CU-1-Walk-In Cooler & CU-2-Walk-In Freezer & CU-3

CU-1-Walk-In Cooler, CU-2-Walk-In Freezer, and CU-3 [REDACTED] are now two years past expected life. Replace condensing units within two years.

Priority Level: 2
Estimated Cost: \$25,140
Remaining Life: 2 Years

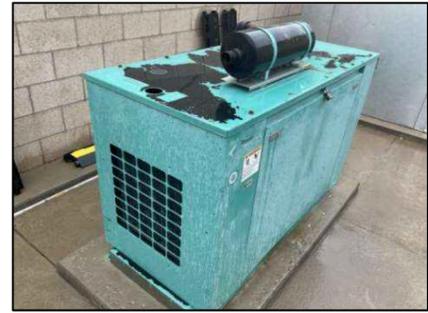
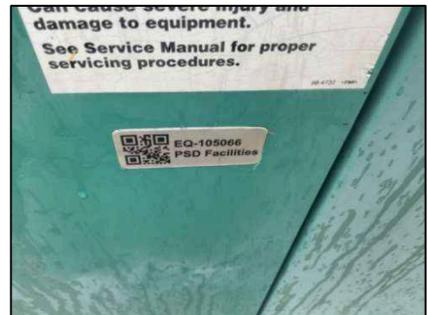
Replace Back-Up Generator

[REDACTED]
[REDACTED]
[REDACTED]. Recommend replacement within three years.

Priority Level: 3
Estimated Cost: \$51,270
Remaining Life: 3 Years

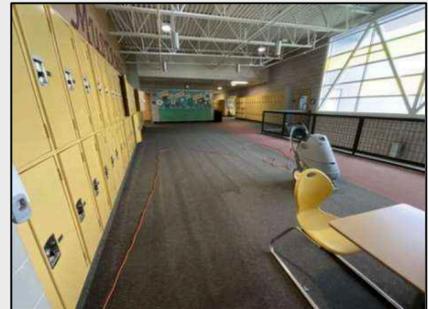
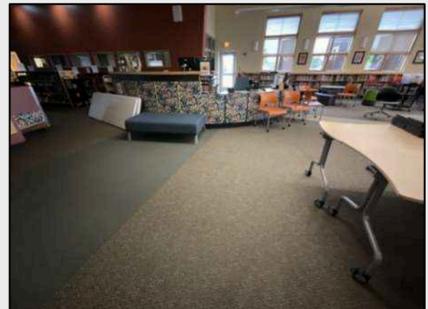
Replace Carpeting

Though the carpeting has been maintained well by PSD Staff, it is now 7 years past expected life. Recommend replacement within two years.

Priority Level: 3
Estimated Cost: \$1,207,710
Remaining Life: 2 Years
